# Replacement of No. 4 Reheat Furnace Roof at Mittal Steel

**Mike Cline - ETS Schaefer Corporation, Macedonia, Ohio**  
**Fred Bellis - Mittal Steel USA, Steelton, Pa.**

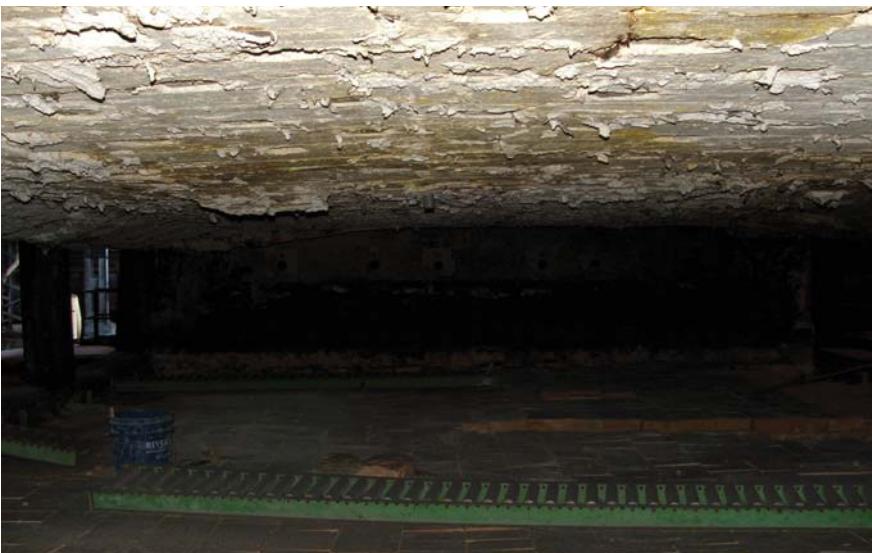
**Fig. 1. Picture of old roof**

consisted of 10-inch thick 45P (plastic) ram suspended from 3-inch beams with hanger bricks and had approximate overall dimensions of 20.5 feet x 49.8 feet. The hot face of the middle of the roof was located approximately 3.75 feet from the hearth but angled slightly upwards at the end-burner walls. The roof also angled downward above the furnace openings to meet the back of the lintel blocks. The contours of the roof would be changed slightly with the new ceramic fiber design. This furnace is typically operated at 2350°F with the furnace pressure not exceeding 0.04"wc. There are six burners on each side of the furnace that rely on recuperative flue checkers for hot air circulation. The air flowing back into the burners from these checkers is approximately 300°F. These burners alternate firing between sides and have a horizontal flame direction, which results in some flame impingement on the hot face of the roof refractory. This was a design concern for the new lining system.

This furnace is shut down each weekend, so thermal shock had always been a major problem. The roof refractory material had been in place for at least 10 years and required frequent repair due to damage caused by thermal shock. The roof had been patched so many times that it began to look like an old quilt. The weekly cooling and heating of the roof was causing excessive failure of the refractory. This in turn created additional maintenance work and downtime.

Cold-face temperatures were measured at 400°F due to the inferior insulating qualities of ram refractory. These high temperatures were also indicative of high heat-loss values. The weekly shutdown of the furnace also created other concerns with the performance of the roof. Due to the high heat-storage values of ram, large amounts of fuel were required to bring the roof temperature back up for operation. When the manufacturer began to see rising natural gas prices, heat loss and heat storage became more important factors in the operation of this furnace.

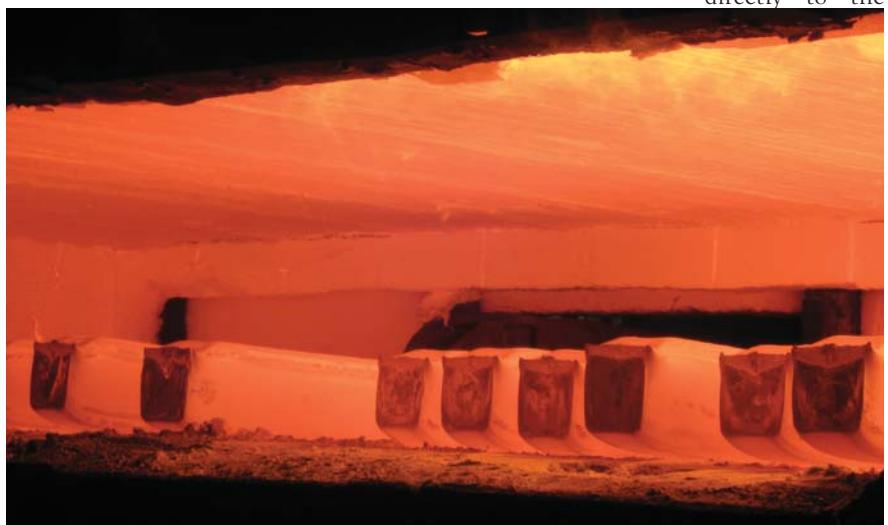
Fig. 4. New roof

These gaskets would prevent any type of leak or hot spot. Once all of the panels were moved into their final positions, they were suspended from the existing furnace structure using threaded rod with fasteners. The roof panels were then welded together on the cold-face structure. The hot face of the lining was then sprayed with a refractory coating to minimize fiber erosion due to flame impingement (Fig. 4).

Now that the furnace is back in operation, an accurate evaluation can be made of the benefits of this roof system. Anticipated problems with flame impingement never materialized, easing any worries about fiber erosion. The maintenance headaches associated with thermal shock have been eliminated because of the fibrous nature of the new lining material. As a result, the weekly shutdown and cooling of the furnace will no longer create problems with the roof lining. Cracking and spalling have disappeared, which has reduced maintenance downtime and caused production to increase.

Fuel savings have been significant. In addition to being able to lower their set point by 125°F, the cold-face temperature of the roof has decreased to 215°F. Mittal Steel's light-off time for this furnace has also decreased from 12 hours to six hours, and fuel consumption to bring the furnace up to operating temperature has been reduced by 81%. Not only do these benefits provide reduced fuel consumption, but they also create a safer environment above and around the furnace. Last but not least, the production rate of this furnace expressed in tons per hour has increased by 15.5%. Increased operating profits associated with these benefits have more than justified the cost of this project (Fig. 3).
